Manhole Inspection Summary

Manhole # S27Q__007MH

Insp Date: **7/6/09 1:16 PM**

Location Address: **1201 Wicomico St.**

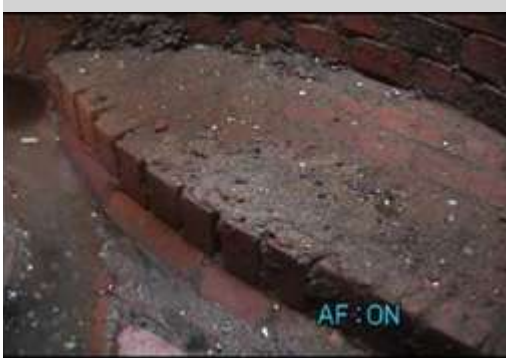
Misc.

debris on the bench

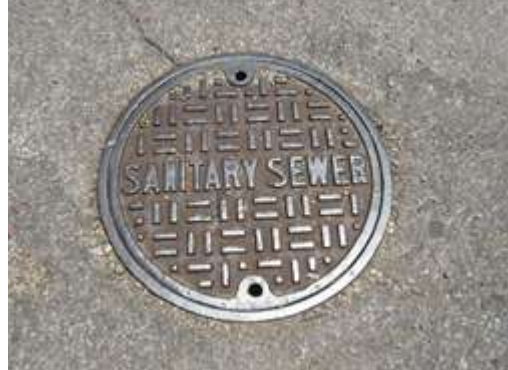
Cover

above grade

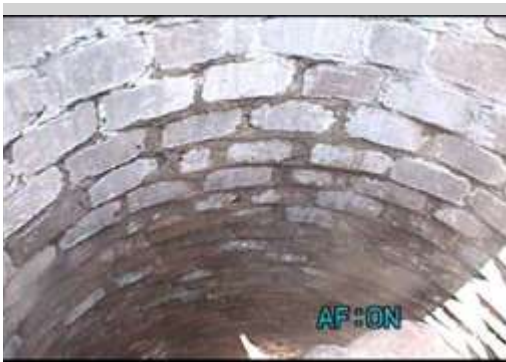
Defect 3

Infiltration: ☐ None ☐ Joint ☐ Cracks ☒ **Mortar** ☐ Roots ☐ Wall

corbel infiltration

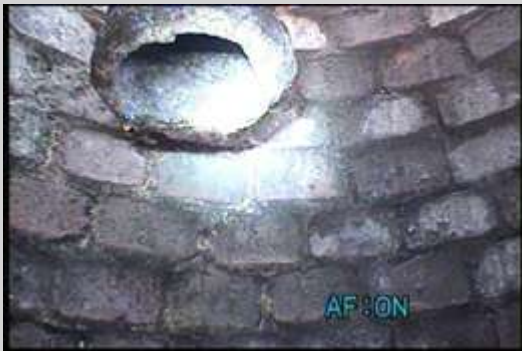
6 O'Clock Inflow

This is a view looking up into the pipe; dont know if these two are related; industrial area.
